Considering a stapler, how are the material choices linked to the mechanical requirements ?

Preparation and experiments:

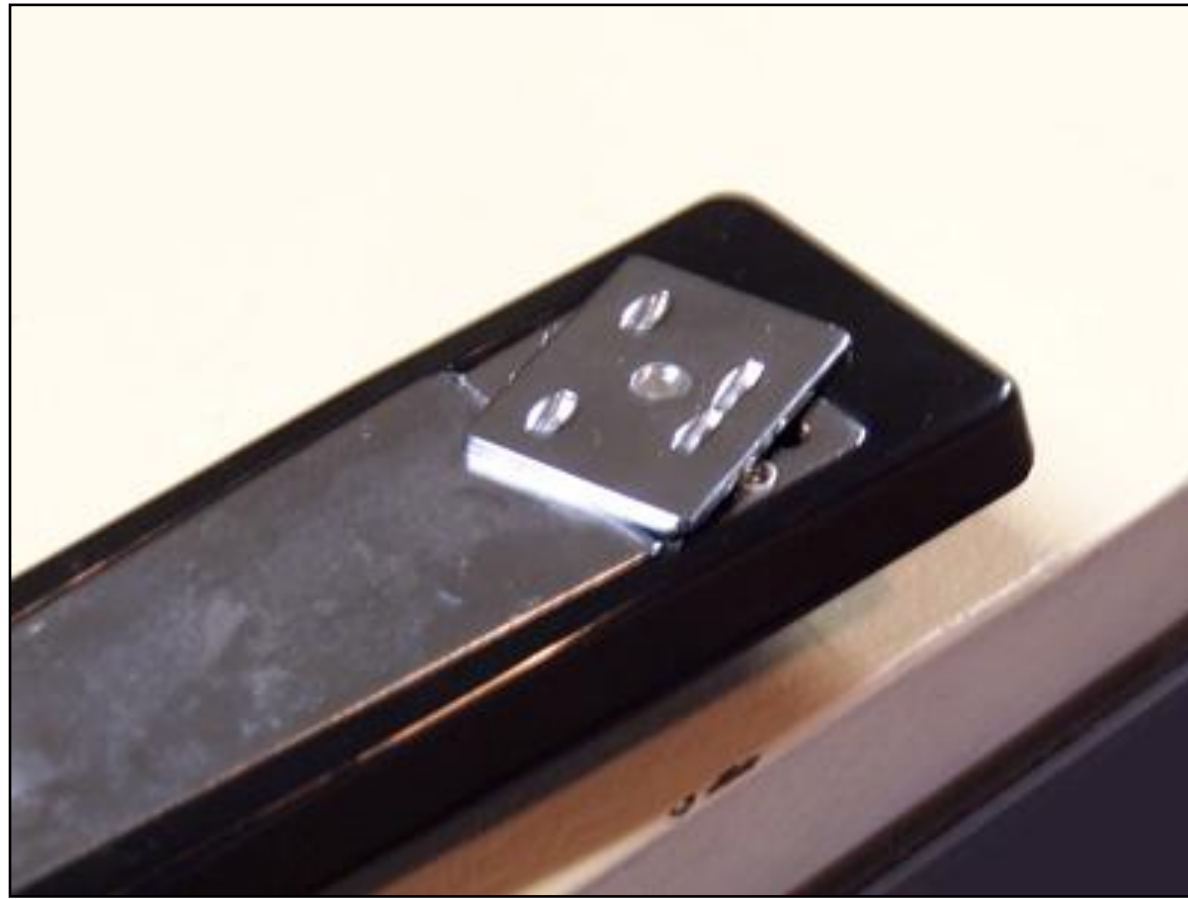
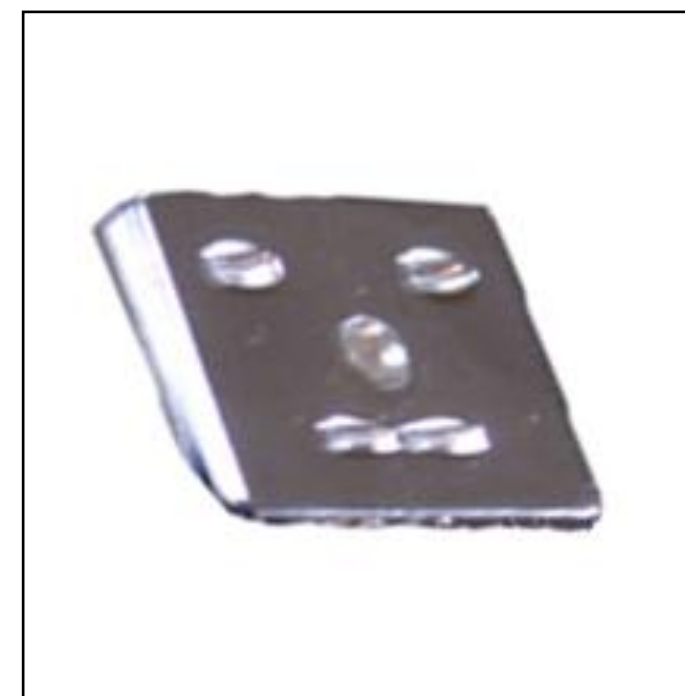
The first thing that has been done for this study is to extract the anvil from the original stapler.

Figure 1: the striking plate

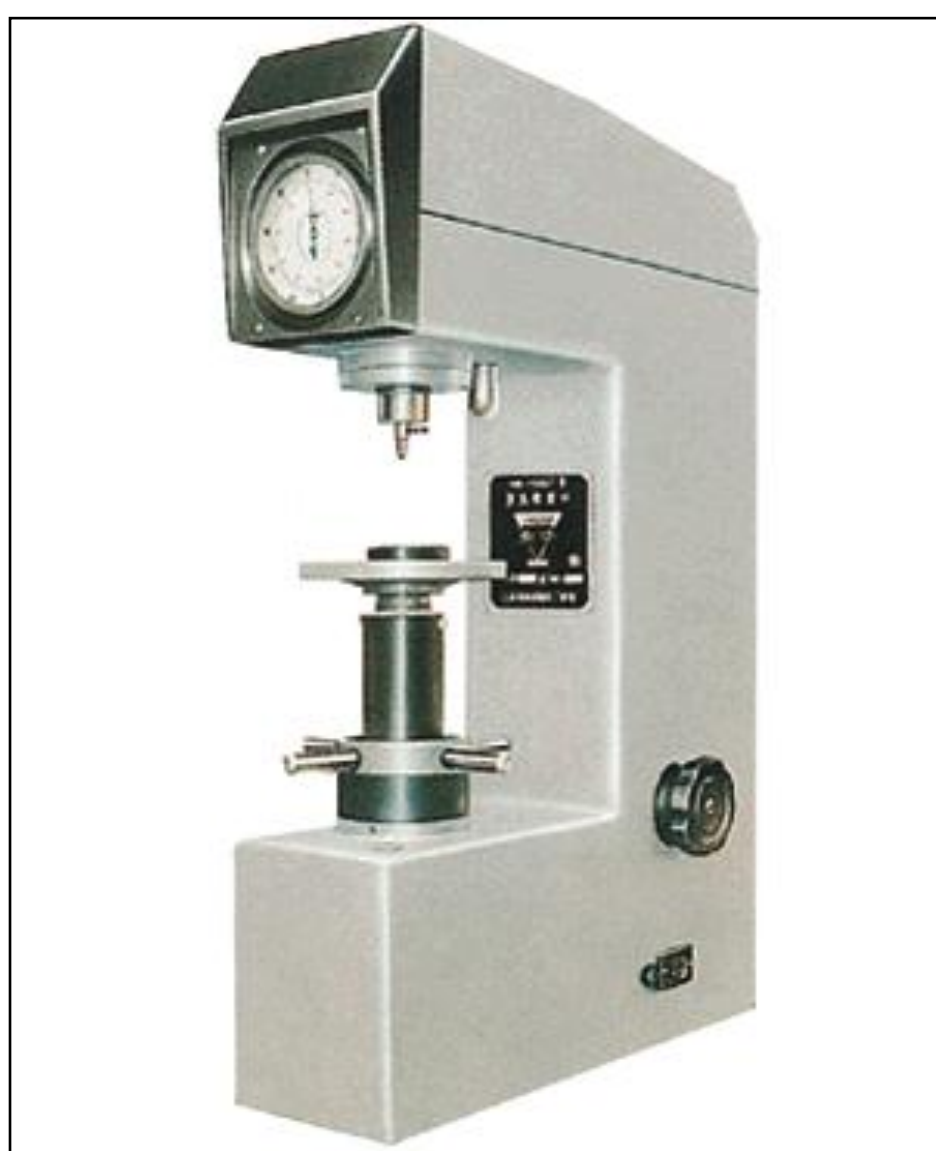
The first one of them was the hardness test. It measures a plastic deformation, or more precisely the size of the indentation left in the material by a diamond shape. The size of the indentation is then easily converted in Vickers hardness via a table. The mechanism can be seen figure 2.

Figure 2: the hardness test

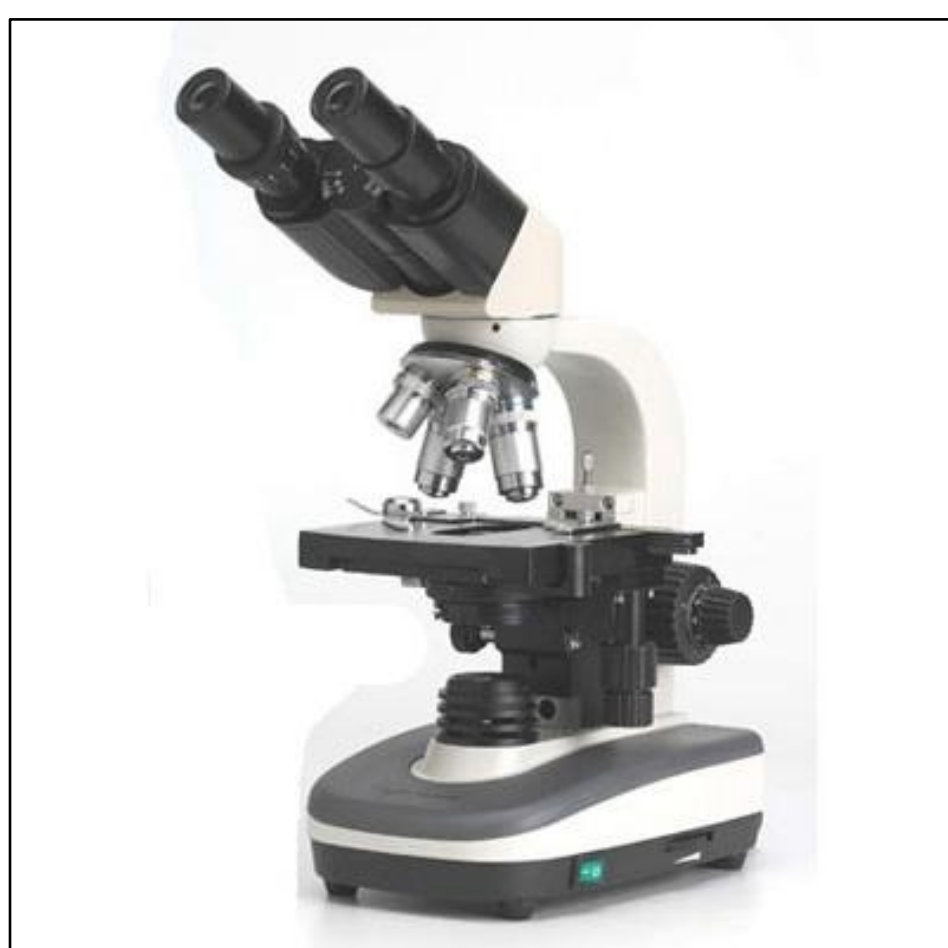
The other two tests were optical microscopy and scanning electron microscopy. The aim was to be able to determine the microstructure and the composition of the specimen in order to link the results to the basic mechanical properties of the striking plate.

Figure 3: Optical microscopy (left) and scanning electron microscopy (right)
